TECHNCIAL NOTE no.: 53	
Product:	Electric harness inspection
Part number:	n/a
To:	Audi RS3 LMS Gen2 and Cupra Leon Competicion
Date:	19/03/2024

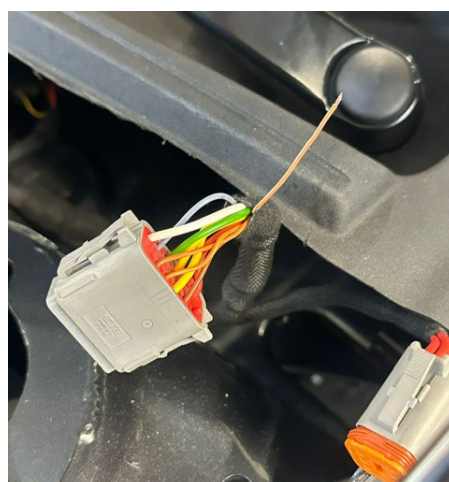
As a cable crimping problem has been reported we are asking you to perform checks on the crimping of the power-box connectors.

The thin brown cables (Power-box ground supply and identification) need to be checked with caution if the crimping is correct and tight.

To perform the check, pull each thin brown cable firmly from behind to check if it's fixed to the pin correctly. Apply appropriate force to check the installation but not to rip out the cable by mistake.

In case of electrical malfunction these connections have to be checked first.

As a precaution it could be a good idea to check all 7 power-box connectors mounted in the car.
