**TECHNCIAL NOTE no.: 22**

Product:	Gearbox Shifting pneumatic system
Part number:	5FR798001
To:	CUPRA Leon Competicion & Audi RS3 LMS
Date:	21/10/2021

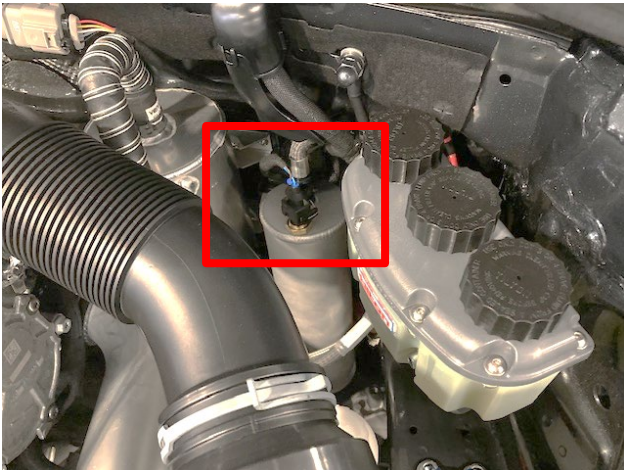
1) Air Temperature sensor in location

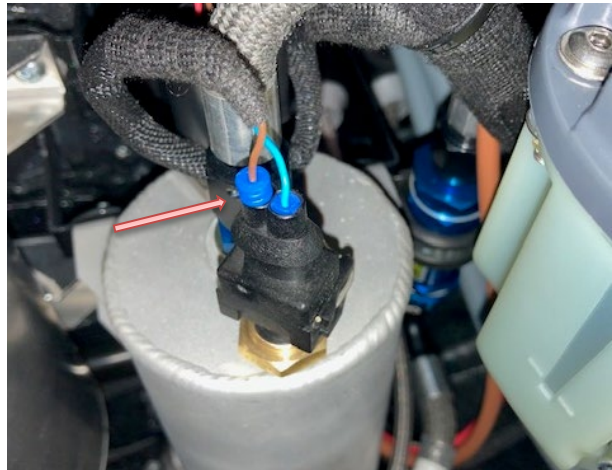
During the 2021 season, there have been some reports regarding a fault in the shifting compressor air temperature sensor, noting air leaks through the sensor in some units.

- a) Because you will see that the silicon seal of the cable has been lifted.
- b) Because the compressor starts very often (check no leakages in the line)

2) Silicon seal lifted due sensor air leaking

In the future, that sensor will be an optional part and a cap will be installed in replacement of the sensor. The connector on the wiring loom will remain in the car.
